**SHARON STEEL OPERABLE UNIT 1
OPERATION & MAINTENANCE
QUARTERLY SITE INSPECTION
MAY 2007
MIDVALE, UTAH**

Prepared by: Tony Howes
Utah Department of Environmental Quality
Division of Environmental Response and Remediation

SHARON STEEL OUI OPERATION & MAINTENANCE

Conditions and Recommendations noted in 5/23/07 Inspection

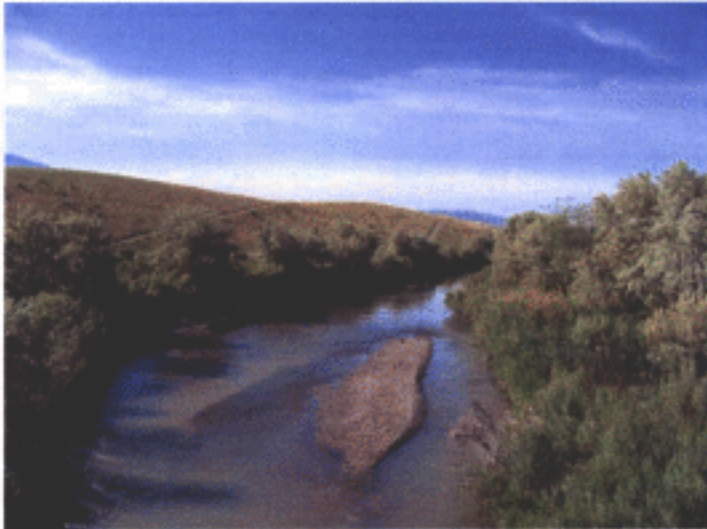
Photo 3 View of Jordan River and west slope of cap 5/23/07

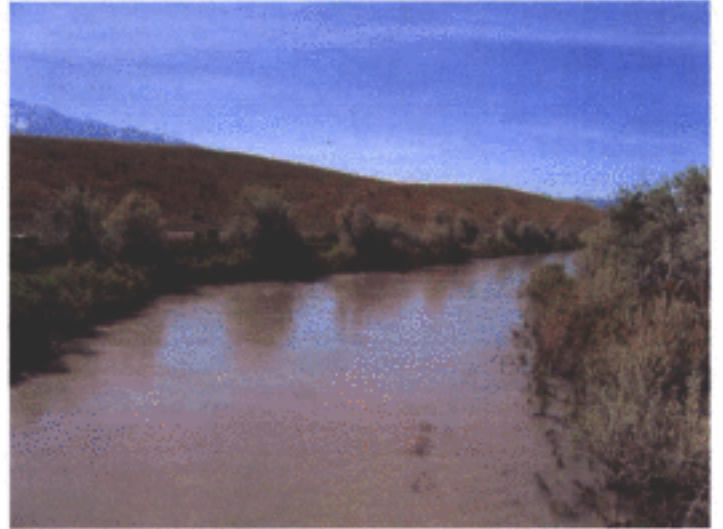
Photo 4 Same view as Photo 3 taken on 5/24/06

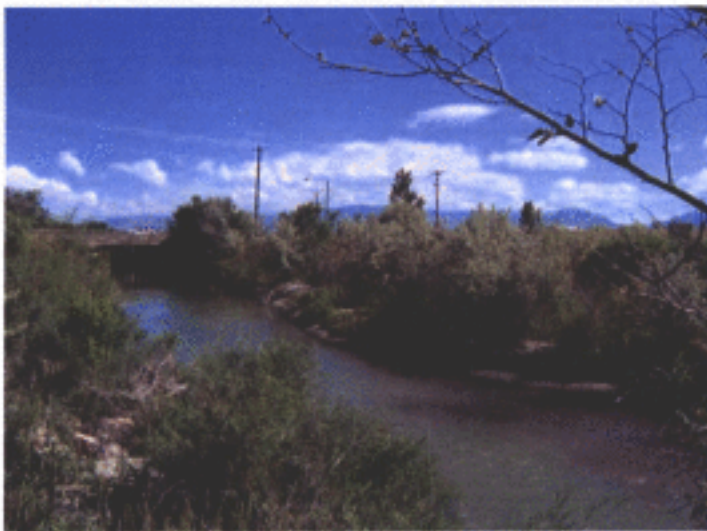
2. **Inspection Action: #10.** Several areas along the banks of the Jordan River have been eroded, as noted in previous inspections and are in need of repair in order to prevent additional erosion.

Photo 5 Jordan River erosion area A on 5/23/07

Steps Taken to Remediate: The UDEQ has consulted with EPA about erosion along the Jordan River (Erosion Areas A through E) and options for restoring those areas are being discussed.

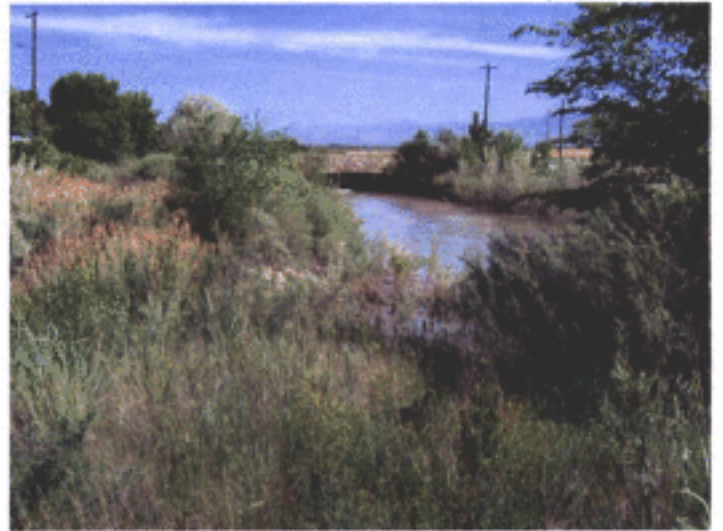
Photo 6 Jordan River erosion area A on 5/24/06

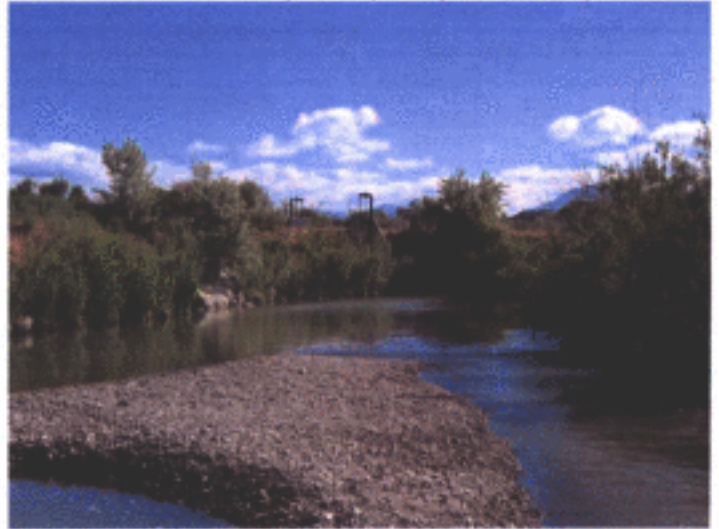
Photo 8 Jordan River Erosion Area E 5/23/07

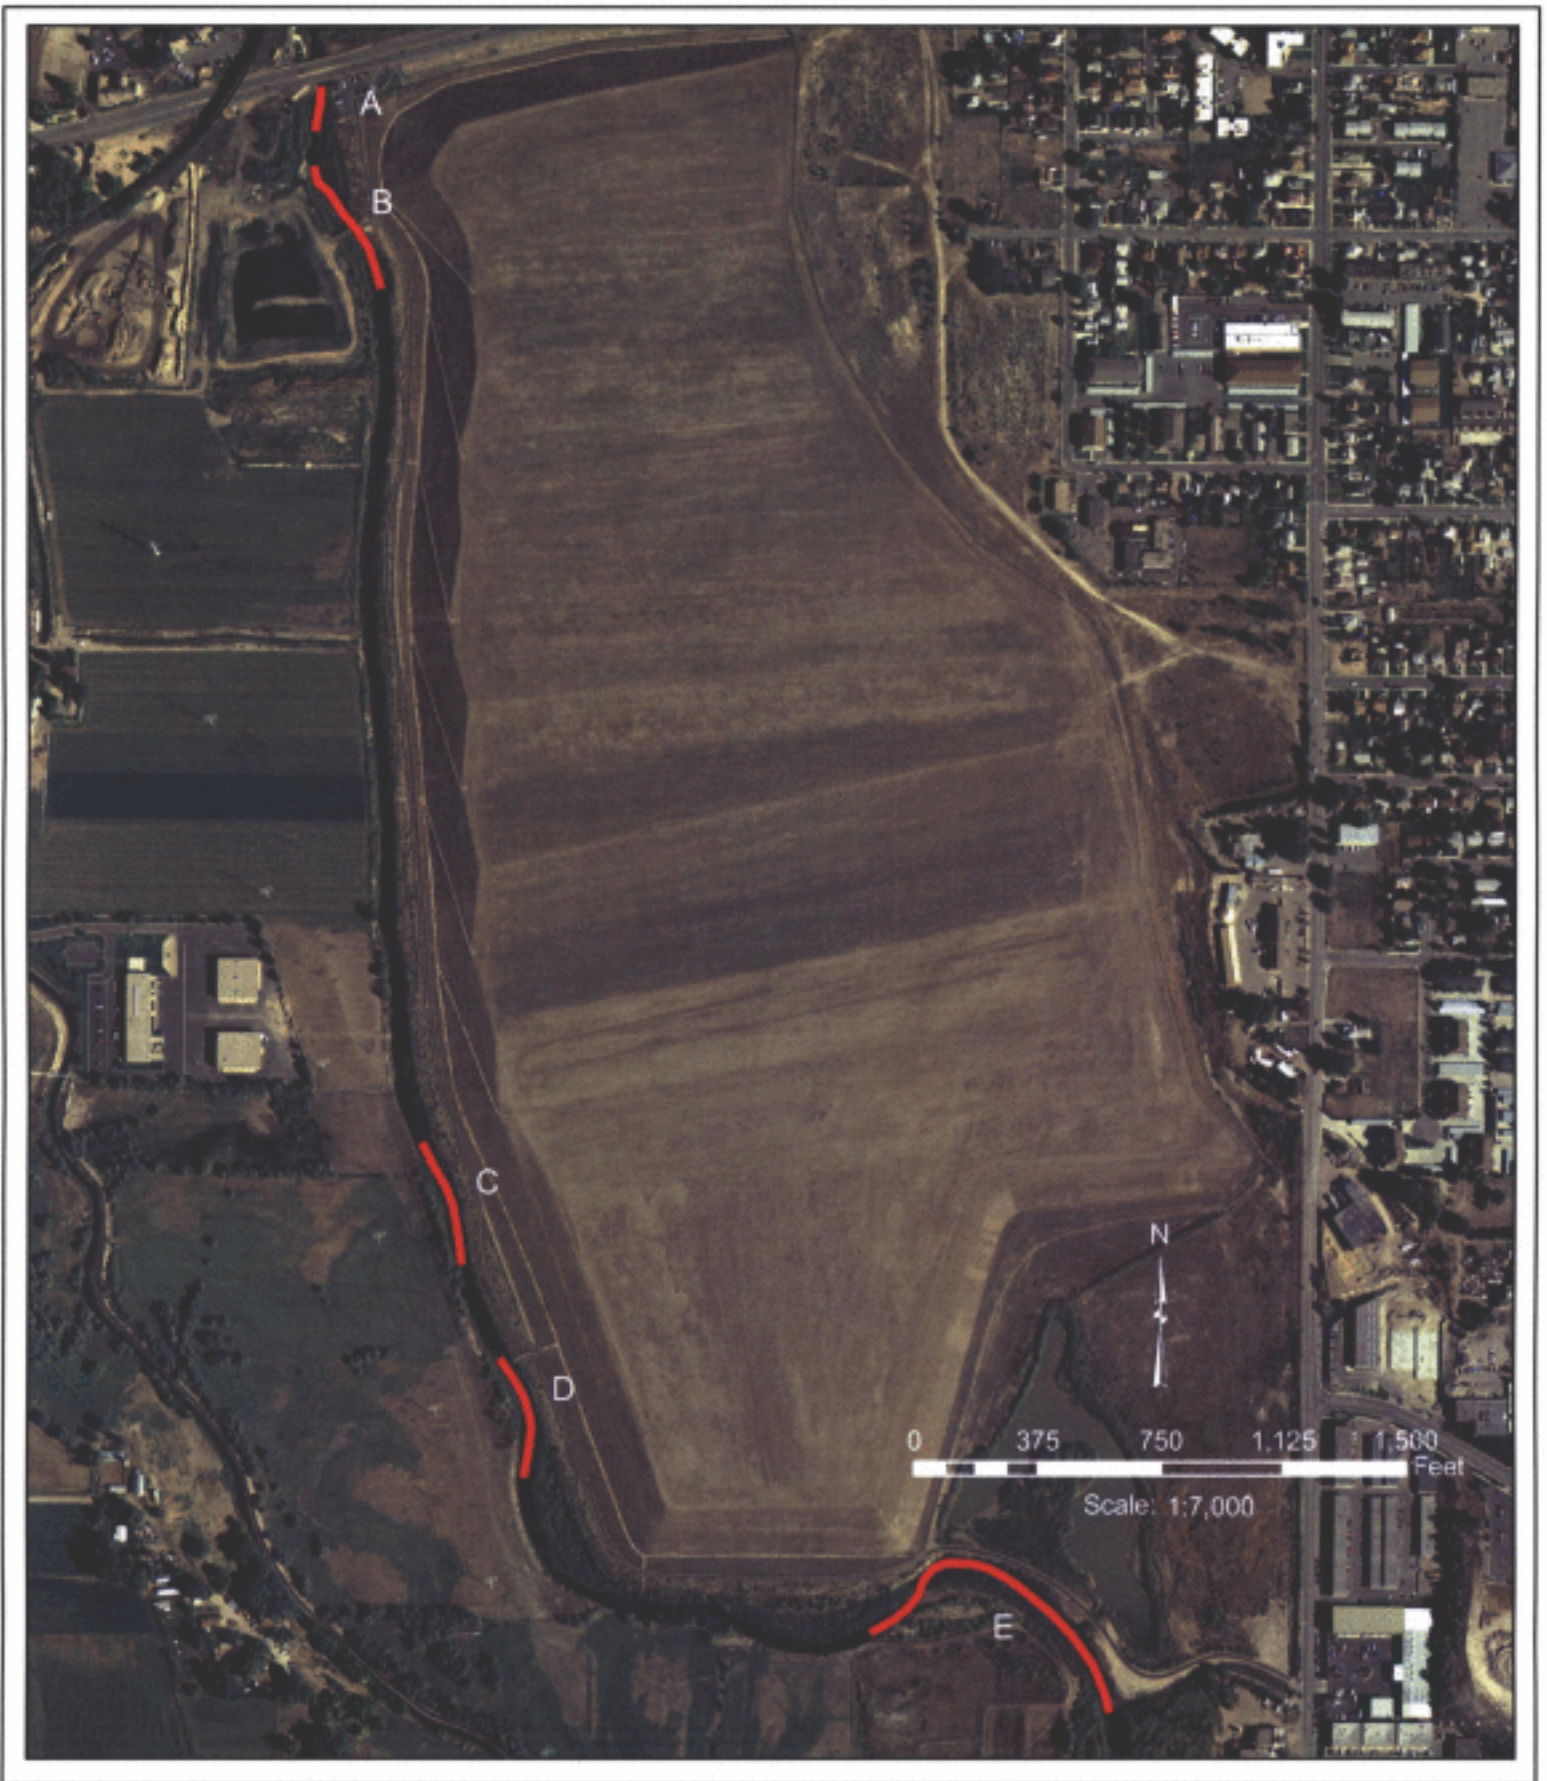
Figure 3
Sharon Steel Operable Unit One
Key Inspection Areas for
Riverbank Stability

Key Inspection Areas for Riverbank Stability
